# Machine Failure and Damage

SLQ Wiki Fabrication Lab 2026/06/13 12:47

This is a non-exhaustive list of our fails with the Trotec Rayjet 300. Please edit and expand as you see fit.

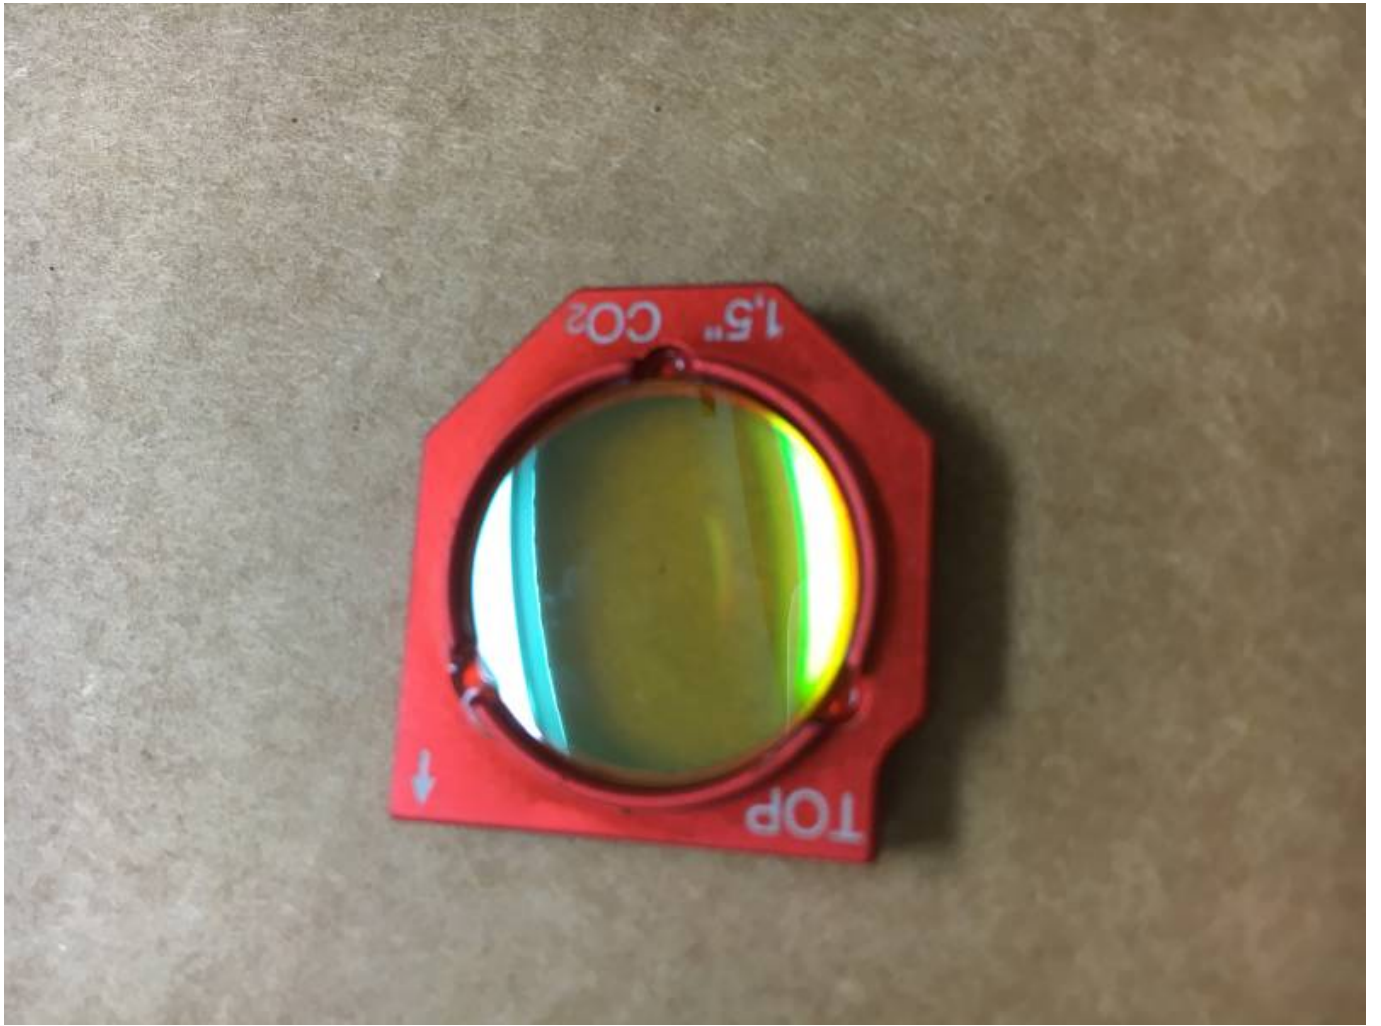
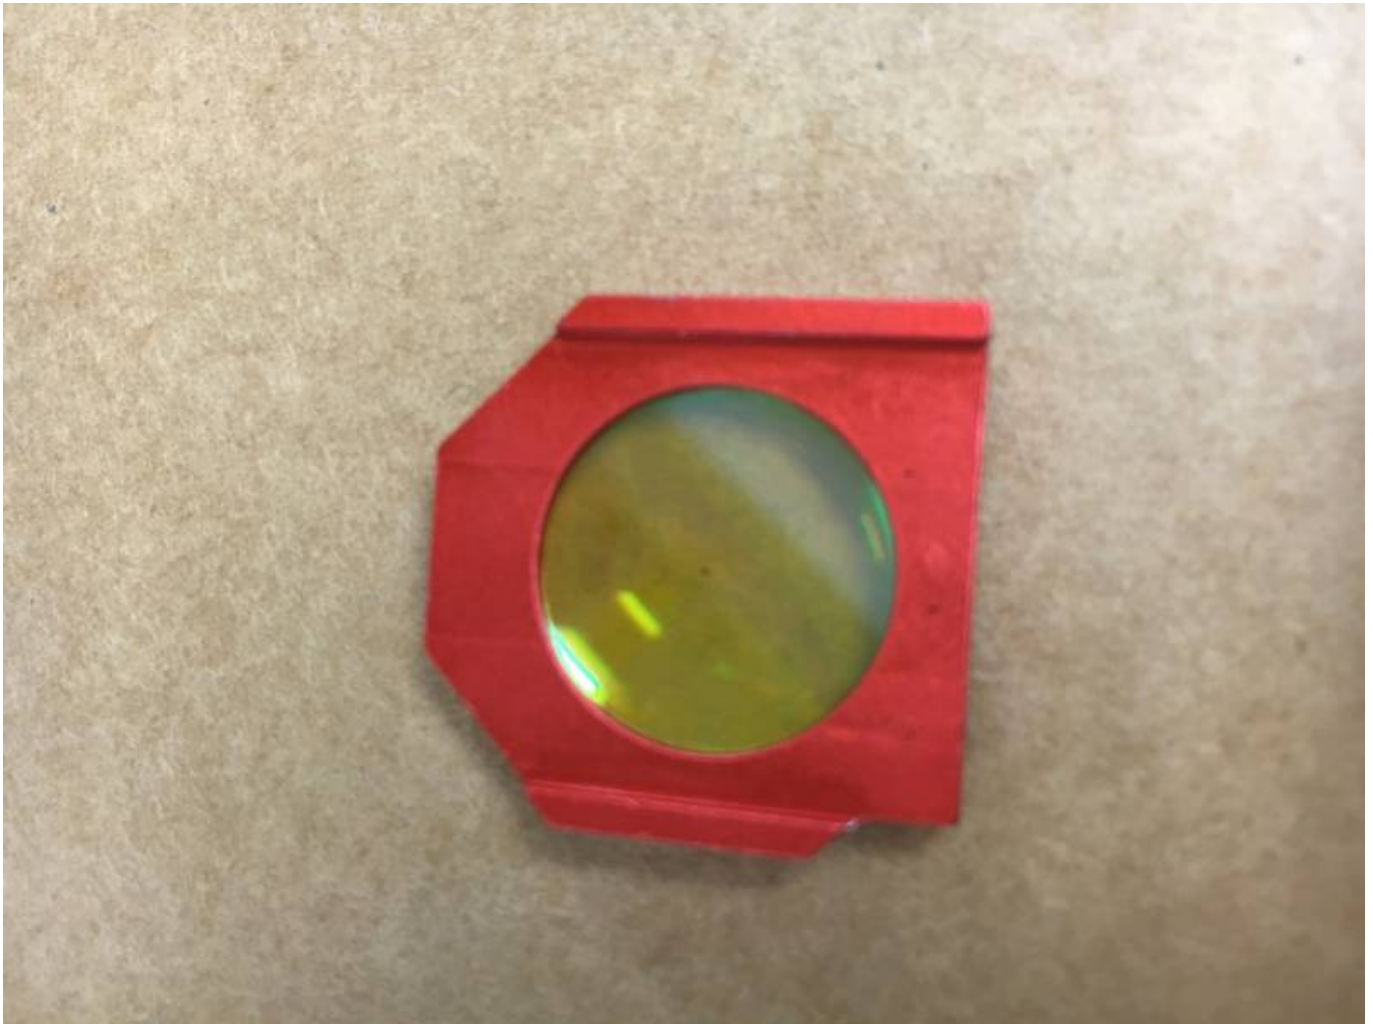
## damaged lens

Thursday 25 Aug Brendan reported crack in the lens found after laser was cutting underpowered.

Michael from trotec came out with Temporary replacement ( different size lens 2") that did not end up fitting. 2x stock lenses (1.5") are on order from Sydney. Michael cleaned damaged lens and said it would be right to use but that it was on its way out.

Photos show black dot inside body of lens. this will grow. Questions to be asked about

- is cleaning being done regularly enough.
- is cleaning being done to the Right standard
- lens being mis handled. finger oil damaging

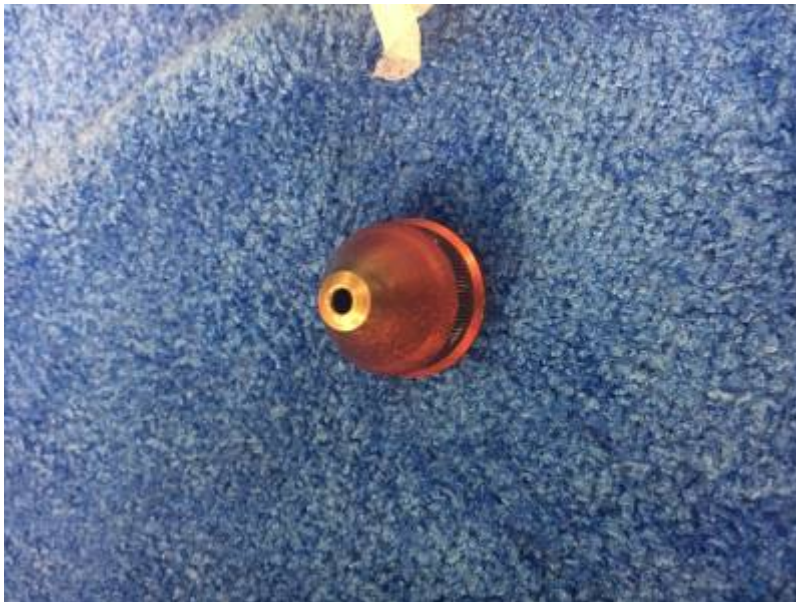
## Heat Damage to Nozzle 06 Oct

Had an incident this evening where the 1st laser job at the HtE was well and truly under power. When i went to inspect the lense i found that all the parts of the Laser Head (Lense, mirror, retaining collar, and head body)was overheated ( approx 60C). We left this to cool before cleaning anything.

The only explanation i can give is that perhaps the trusted participant that cleaned the Laser after their session accidentally or unknowingly reassembled the Lense/retaining collar upside down. (Lense on top of collar for 2"; lense Collar on top of Lense for 1.5" lense) This would have put the laser beam badly out of focus and directed energy at the nozzle which is now heat affected.

This is just a theory... i don't know for sure and wouldn't want to blame this participant. However if it is true the incident points possibly to a failure to communicate new procedures to the couple of trusted participants we allow to clean the machine and possibly to other level 3 facilitators we'd trust to operate and supervise the machine.

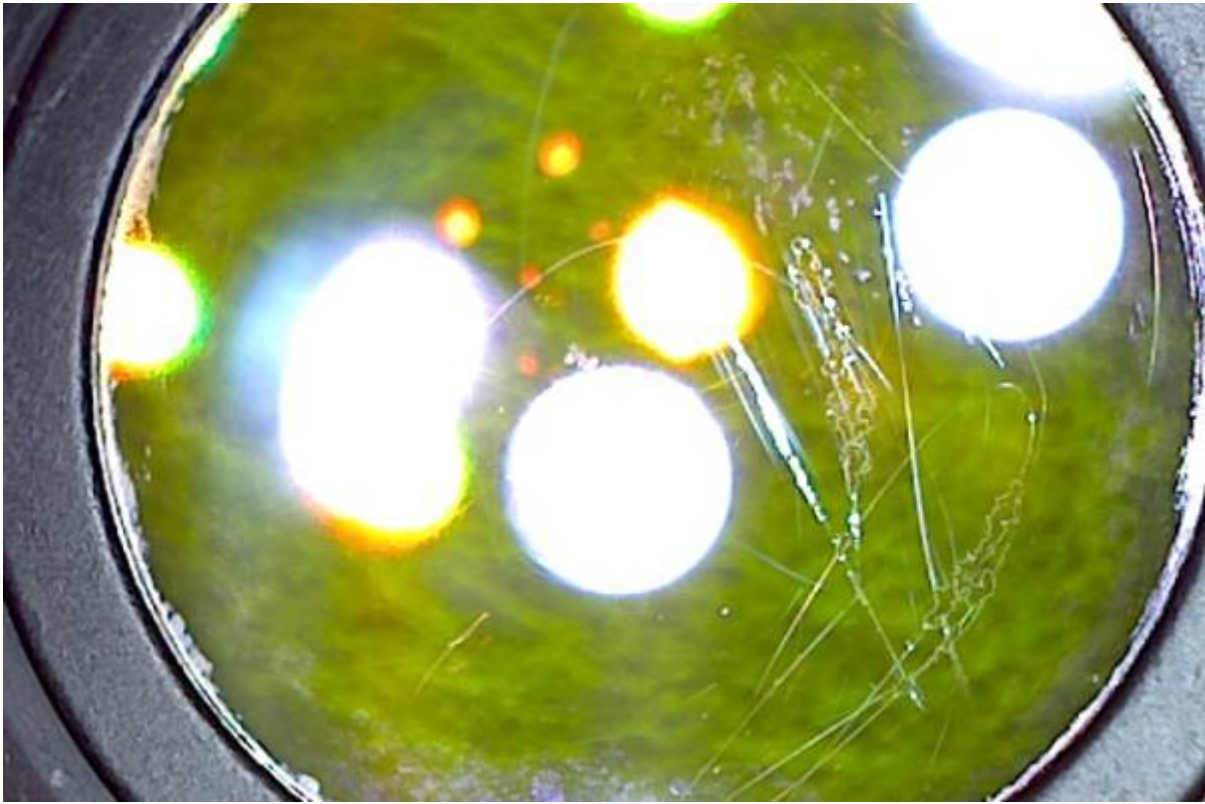
This is a heavily used lens - notice the damage to the lens coating and scratches.

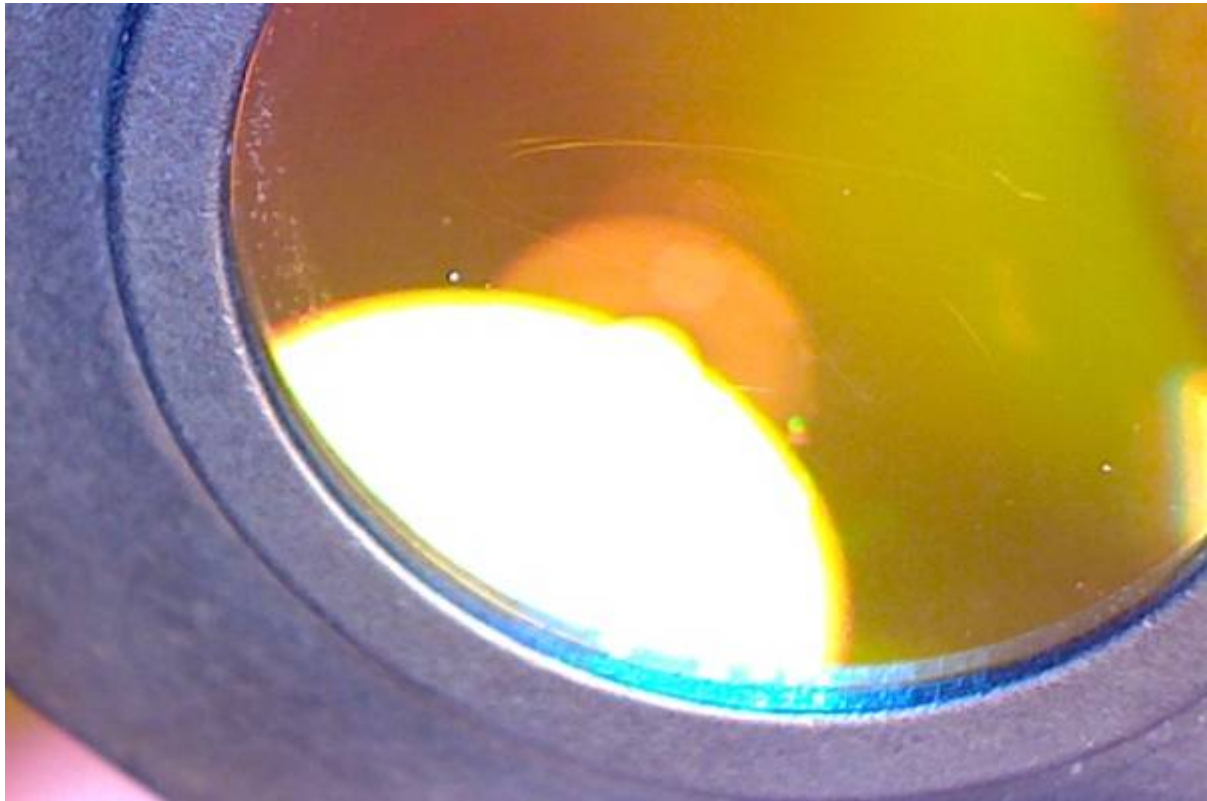
This is the brand new lens - received in the first week on March 2017. Already scratched by 6/03/2017.

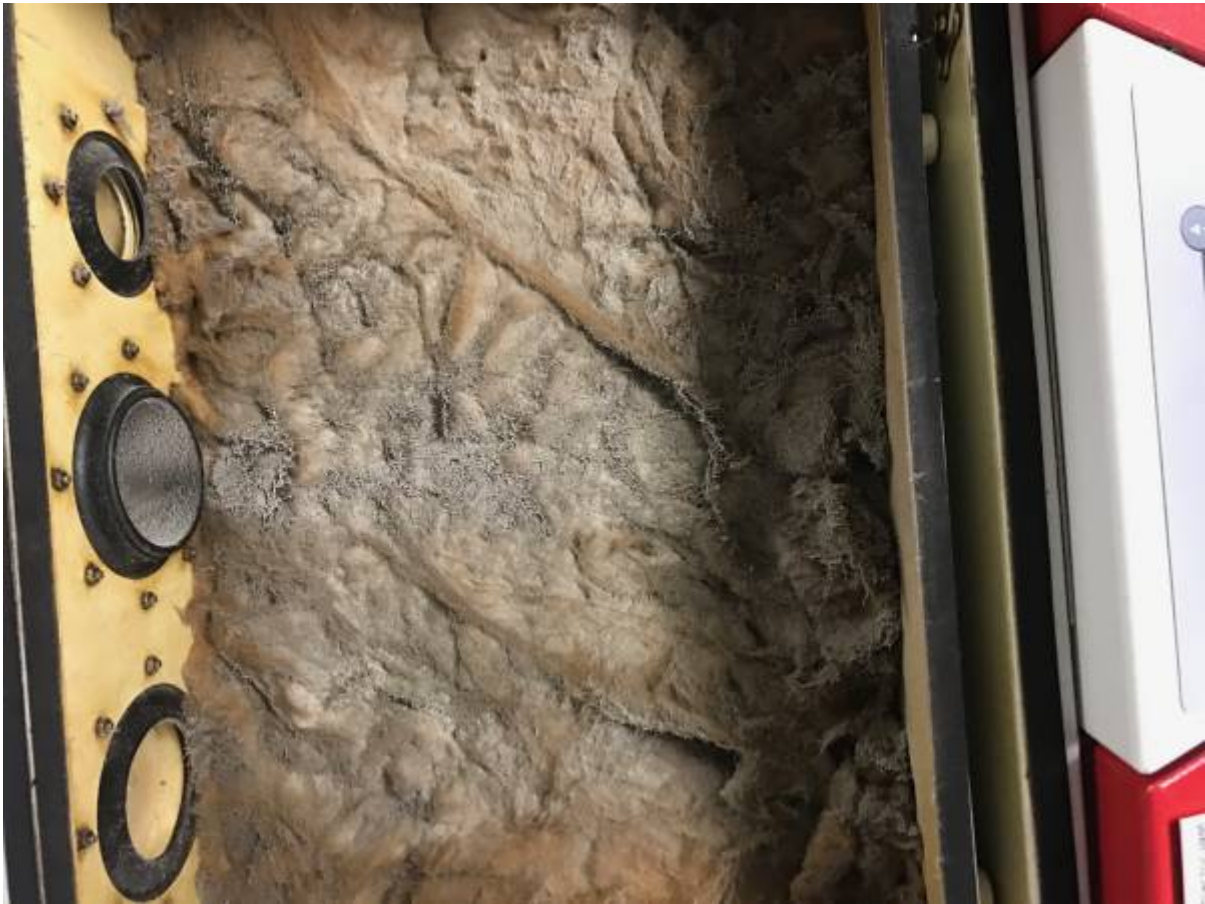
## Filthy ATOMOS Filter

The filter had not been cleaned in over two months. The pre-filter was caked solid with materials and the HEPA component of the filter system blew out. Would suggest that this as a direct result of the lack of cleaning and maintenance on the system and that this shortened the life of the filter.

- Suggest that established maintenance schedule be adhered to.
- Suggest that the date on the *last cleaned* acrylic sign be changed to *due to be changed*
