Machine Failure and Damage

SLQ Wiki Fabrication Lab 2026/01/11 00:31

This is a non-exhaustive list of our fails with the Trotec Rayjet 300. Please edit and expand as you see fit.

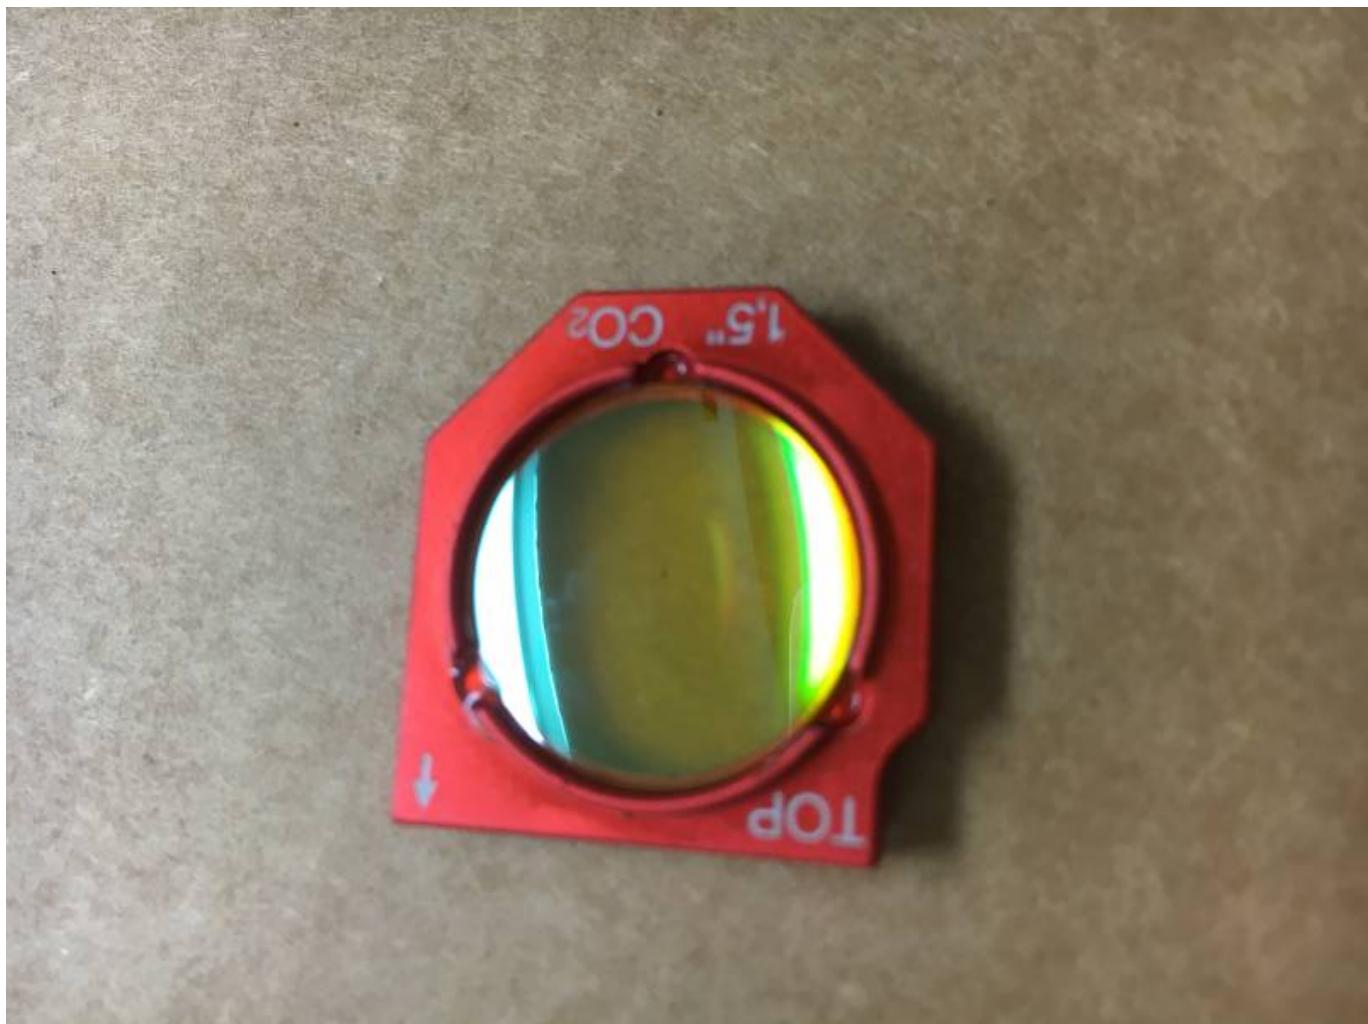
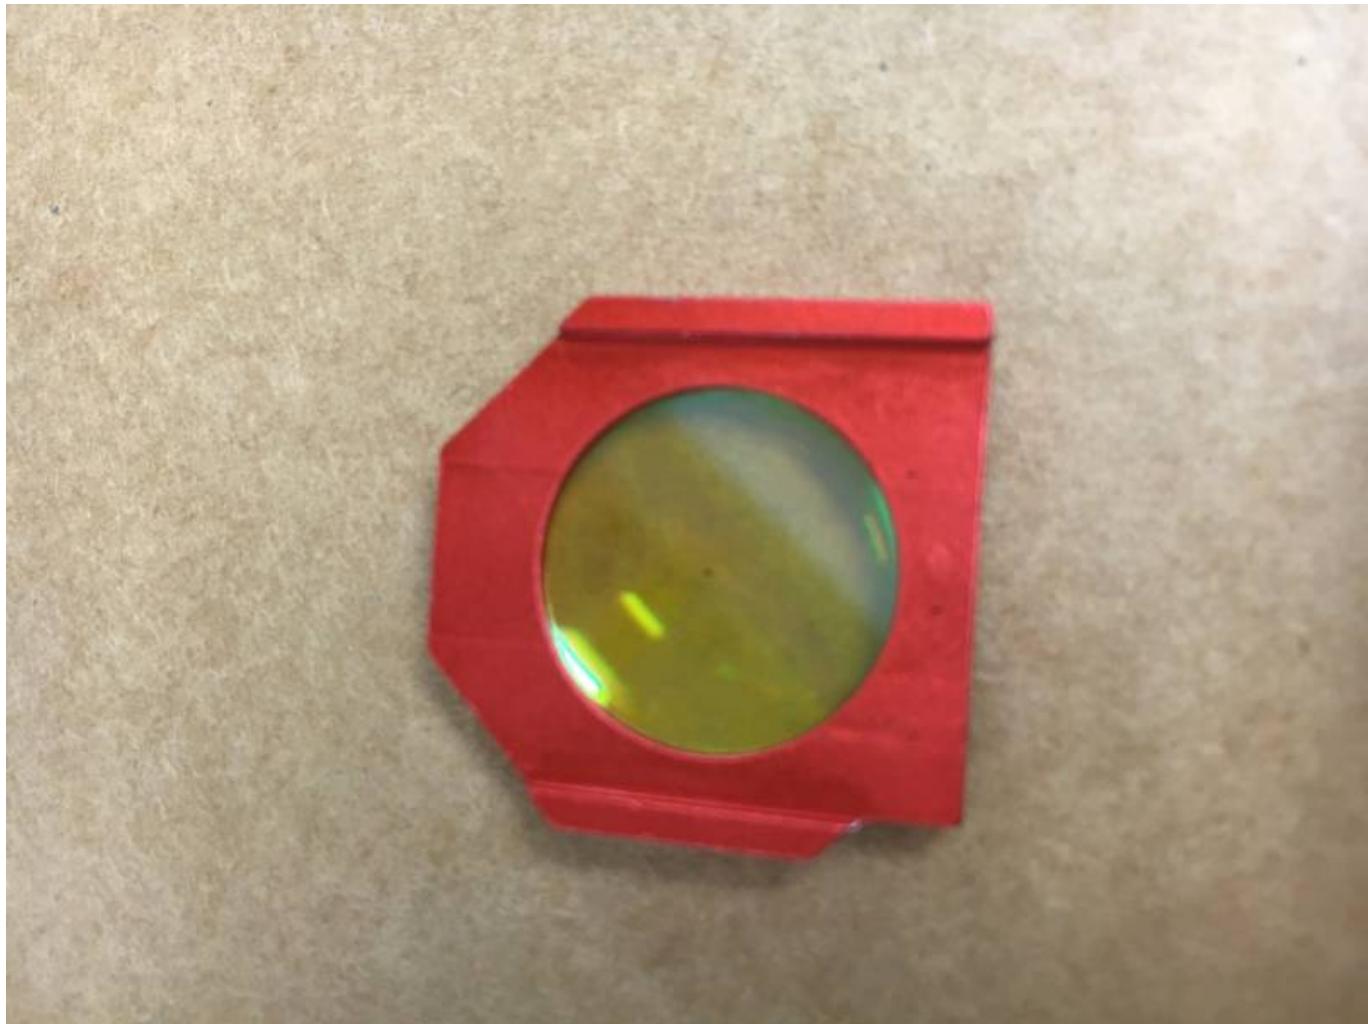
Thursday 25 Aug Brendan reported crack in the lens found after laser was cutting underpowered.

Michael from trotec came out with Temporary replacement (different size lens 2") that did not end up fitting. 2x stock lenses (1.5") are on order from Sydney. Michael cleaned damaged lens and said it would be right to use but that it was on its way out.

Photos show black dot inside body of lens. this will grow. Questions to be asked about

- is cleaning being done regularly enough.
- is cleaning being done to the Right standard
- lens being mis handled. finger oil damaging

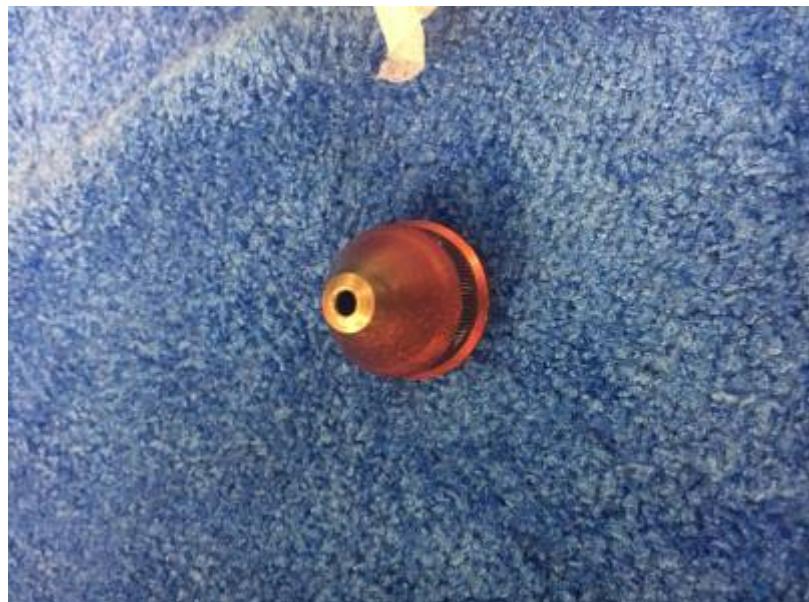
Heat Damage to Nozzle 06 Oct

Had an incident this evening where the 1st laser job at the HtE was well and truly under power. When i went to inspect the lense i found that all the parts of the Laser Head (Lense, mirror, retaining collar, and head body) was overheated (approx 60C). We left this to cool before cleaning anything.

The only explanation i can give is that perhaps the trusted participant that cleaned the Laser after their session accidentally or unknowingly reassembled the Lense/retaining collar upside down. (Lense on top of collar for 2"; lense Collar on top of Lense for 1.5" lense) This would have put the laser beam badly out of focus and directed energy at the nozzle which is now heat affected.

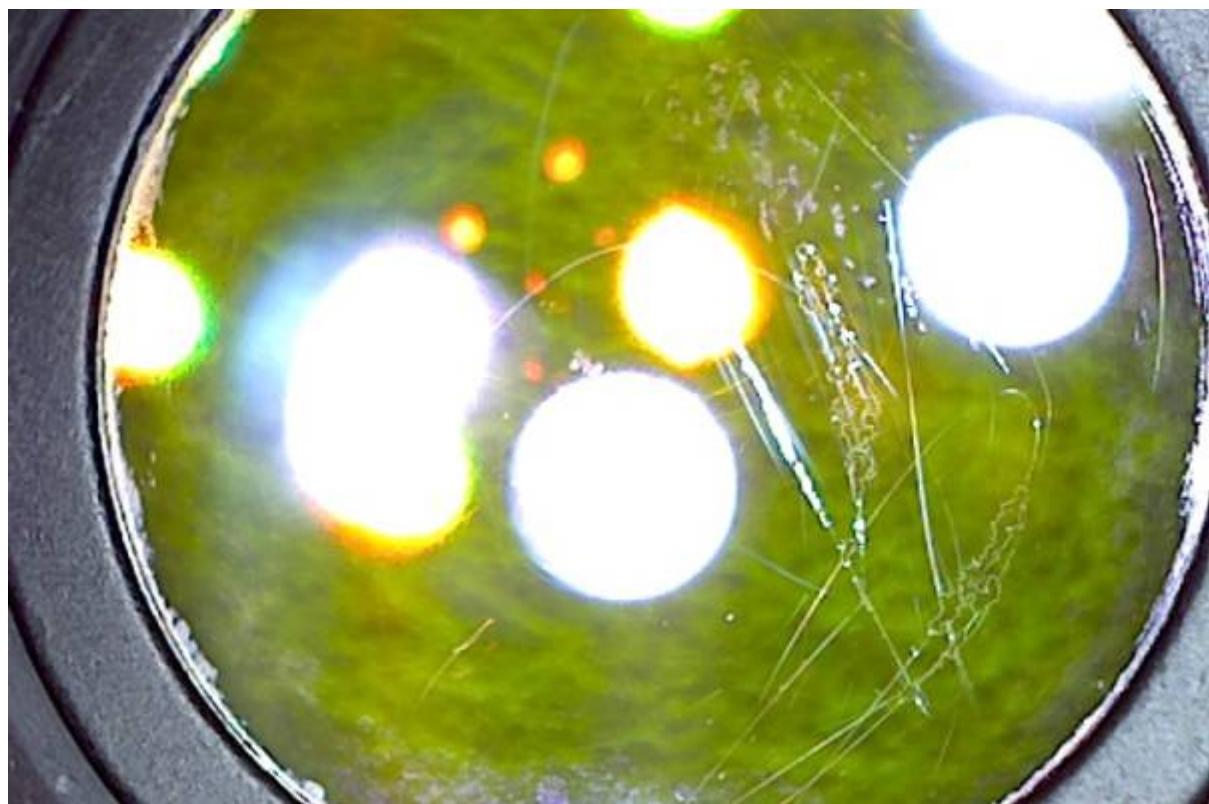
This is a heavily used lens - notice the damage to the lens coating and scratches.

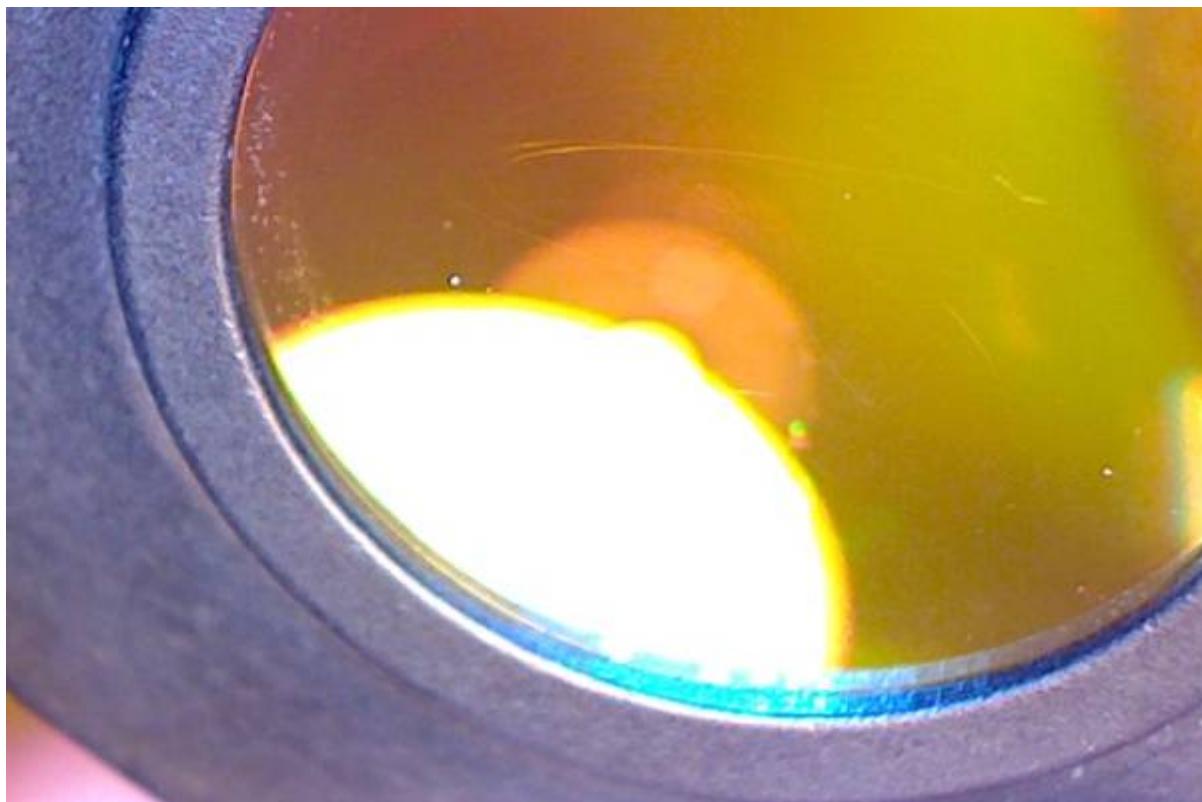
This is the brand new lens - received in the first week on March 2017. Already scratched by 6/03/2017.

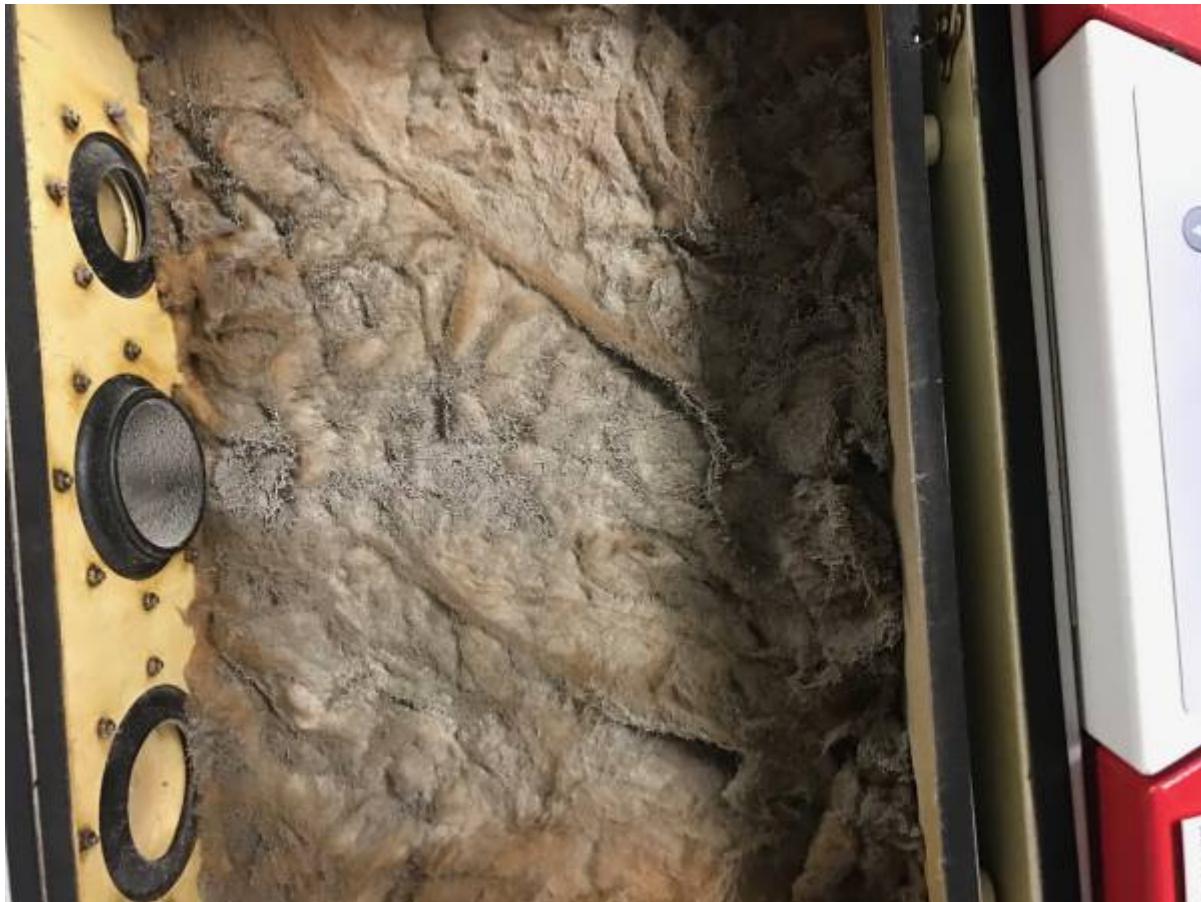
Filthy ATOMOS Filter

The filter had not been cleaned in over two months. The pre-filter was caked solid with materials and the HEPA component of the filter system blew out. Would suggest that this as a direct result of the lack of cleaning and maintenance on the system and that this shortened the life of the filter.

- Suggest that established maintenance schedule be adhered to.
- Suggest that the date on the *last cleaned* acrylic sign be changed to *due to be changed*
