Machine Failure and Damage

SLQ Wiki Fabrication Lab 2024/10/02 14:38

This is a non-exhaustive list of our fails with the Trotec Rayjet 300. Please edit and expand as you see fit.

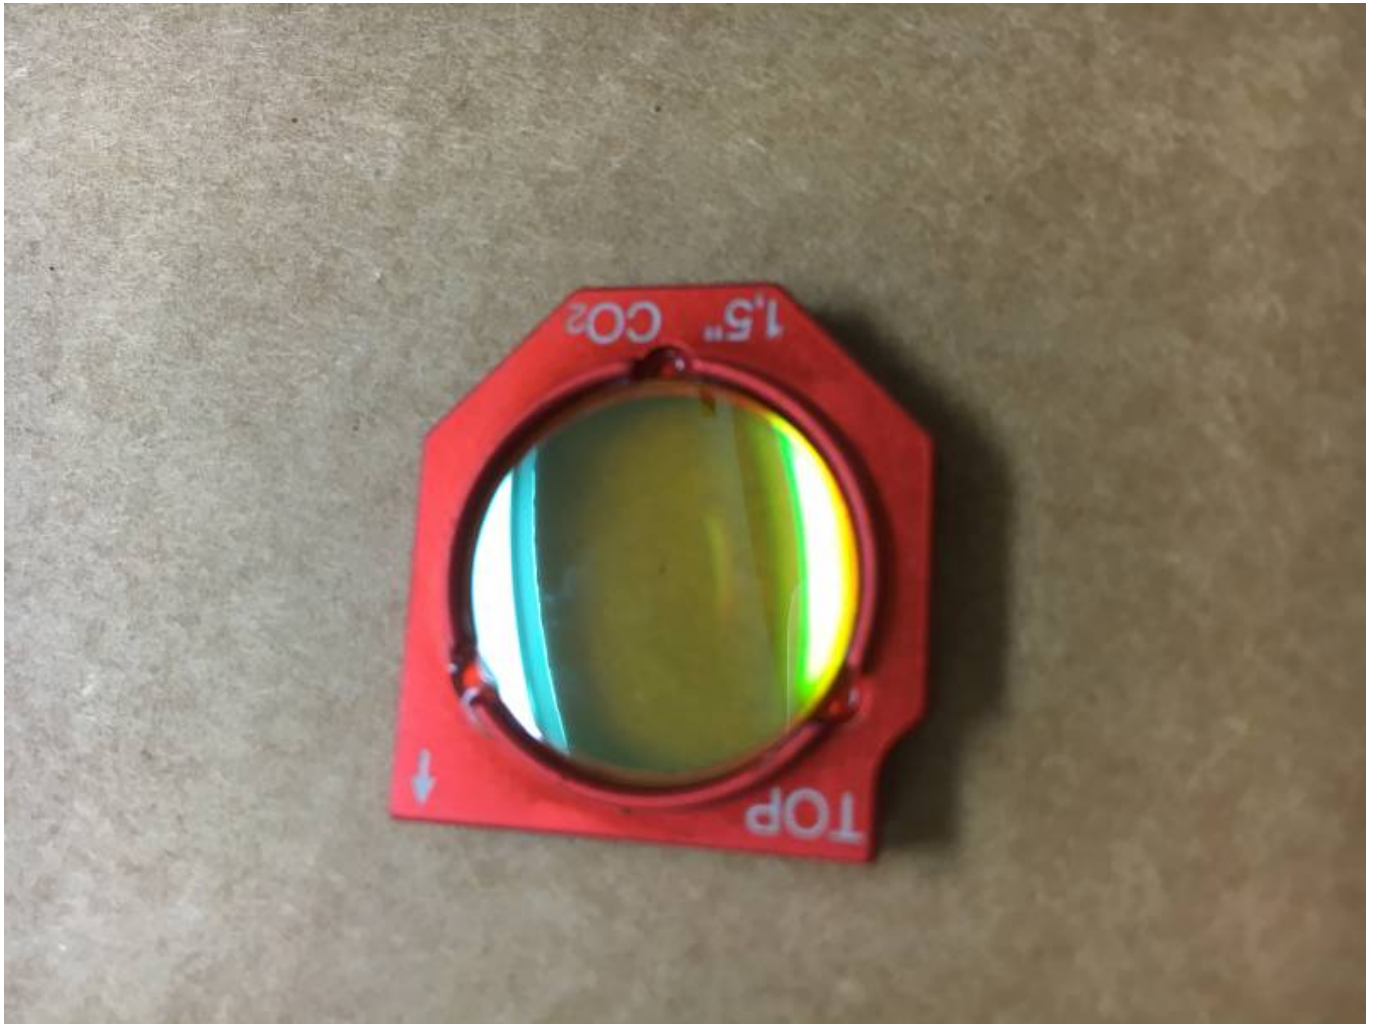
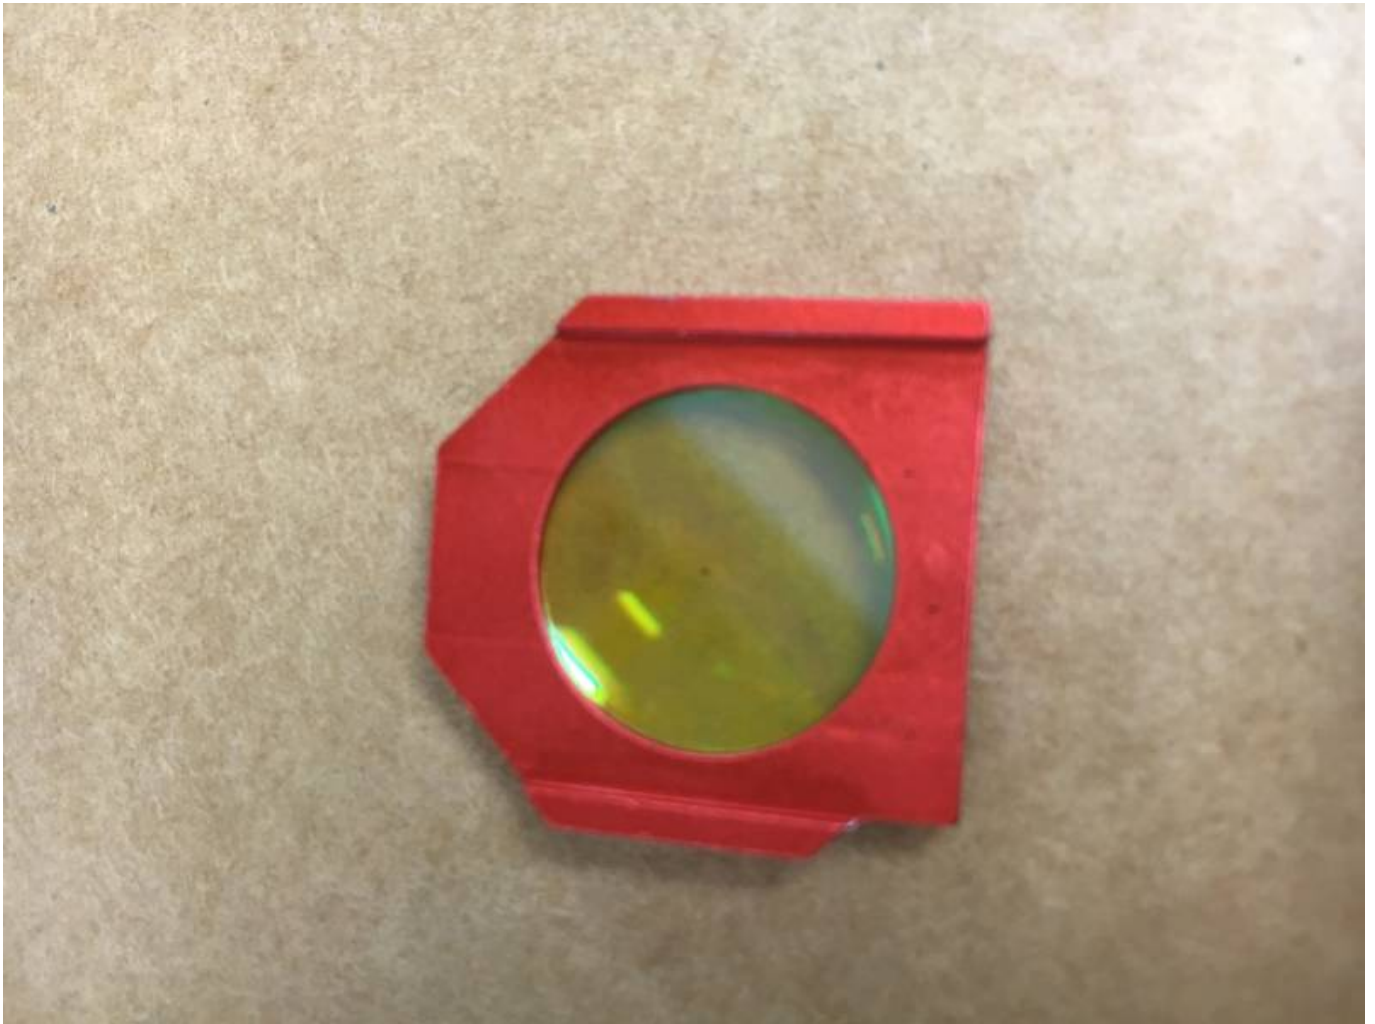
Thursday 25 Aug Brendan reported crack in the lens found after laser was cutting underpowered.

Michael from trotec came out with Temporary replacement (different size lens 2") that did not end up fitting. 2x stock lenses (1.5") are on order from Sydney. Michael cleaned damaged lens and said it would be right to use but that it was on its way out.

Photos show black dot inside body of lens. this will grow. Questions to be asked about

- is cleaning being done regularly enough.
- is cleaning being done to the Right standard
- lens being mis handled. finger oil damaging

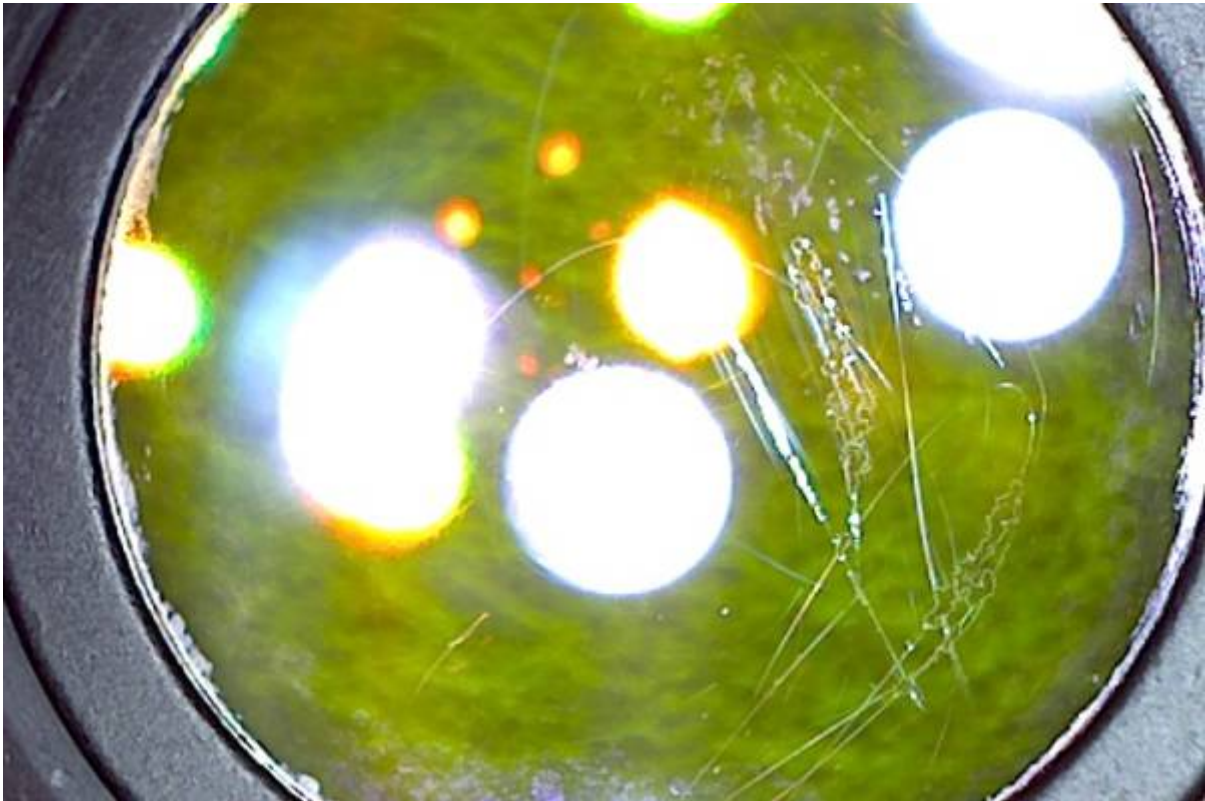
This is a heavily used lens - notice the damage to the lens coating and scratches.
