Machine Failure and Damage

SLQ Wiki Fabrication Lab 2024/05/22 16:18

This is a non-exhaustive list of our fails with the Trotec Rayjet 300. Please edit and expand as you see fit.

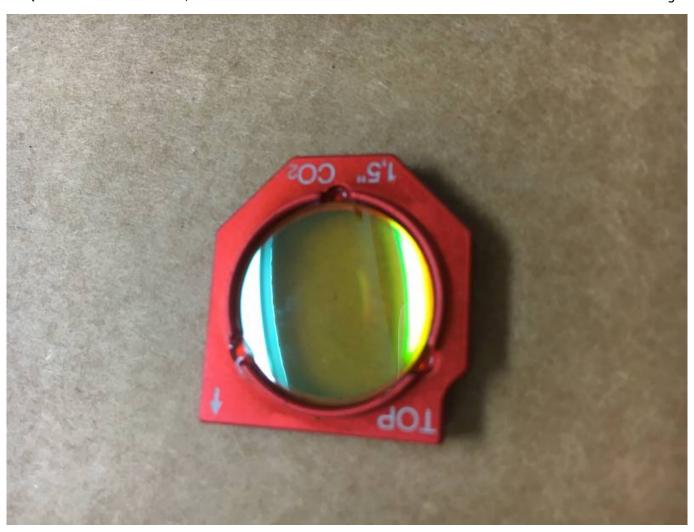
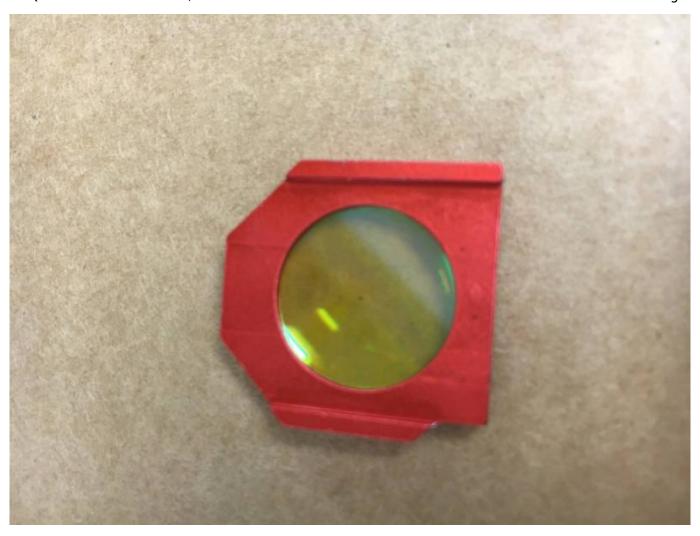
Thursday 25 Aug Brendan reported crack in the lens found after laser was cutting underpowered.

Michael from trotec came out with Temporary replacement (different size lens 2") that did not end up fitting. 2x stock lenses (1.5") are on order from Sydney. Michael cleaned damaged lens and said it would be right to use but that it was on its way out.

Photos show black dot inside body of lens. this will grow. Questions to be asked about

- is cleaning being done regularly enough.
- is cleaning being done to the Right standard
- lens being mis handled, finger oil damaging

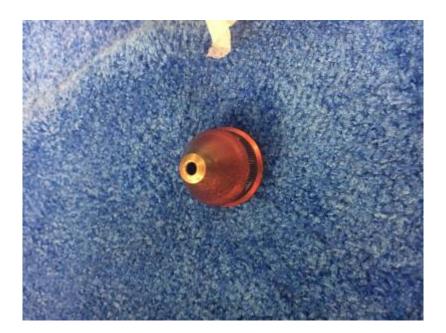
Heat Damage to Nozzle 06 Oct

Had an incident this evening where the 1st laser job at the HtE was well and truely under power. When i went to inspect the lense i found that all the parts of the Laser Head (Lense, mirror, retaining collar, and head body)was overheated (approx 60C). We left this to cool before cleaning anything.

The only explanation i can give is that perhaps the trusted participant that cleaned the Laser after their session accidently or unknowingly reassembled the Lense/retaining collar upside down. (Lense on top of collar for 2"; lense Collar on top of Lense for 1.5" lense) This would have put the laser beam badly out of focus and directed energy at the nozzle which is now heat affected.

This is just a theory... i don't know for sure and wouldn't want to blame this participant. However if it is true the incident points possibly to a failure to communicate new procedures to the couple of trusted participants we allow to clean the machine and possibly to other level 3 facilitators we'd trust to operate and supervise the machine.

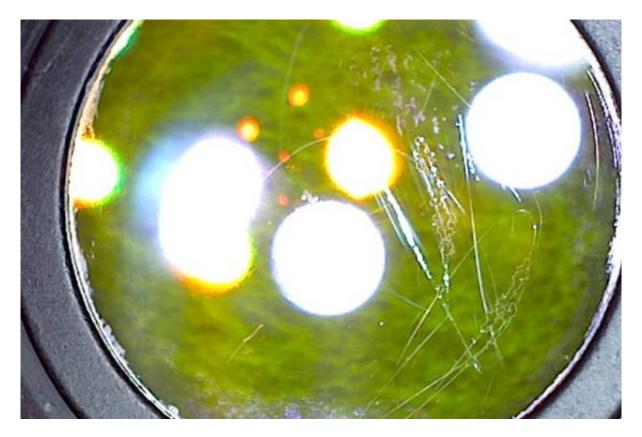
This is a heavily used lens - notice the damage to the lens coating and scratches.

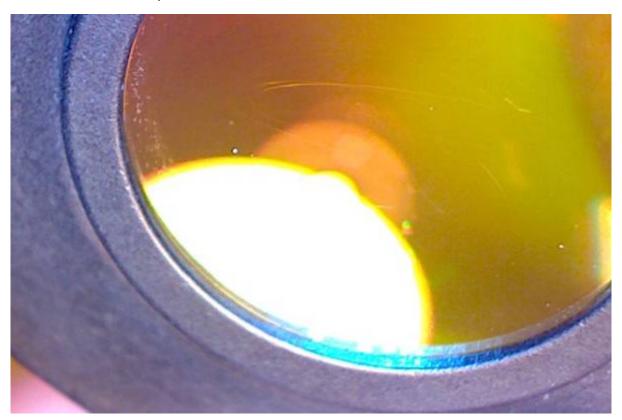
This is the brand new lens - received in the first week on March 2017. Already scratched by 6/03/2017.

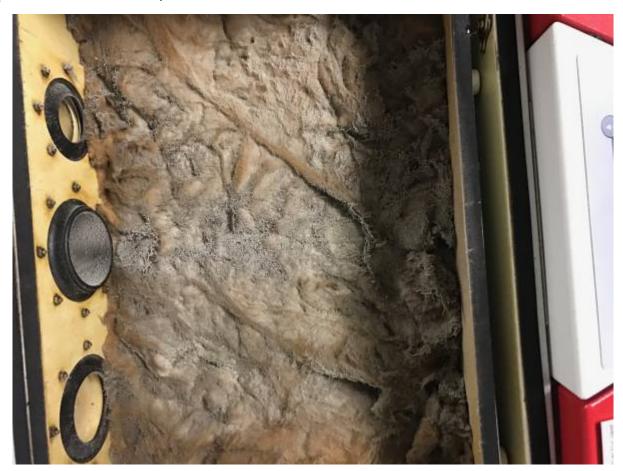
Filthy ATOMOS Filter

The filter had not been cleaned in over two months. The pre-filter was caked solid with materials and the HEPA component of the filter system blew out. Would suggest that this as a direct result of the lack of cleaning and maintenance on the system and that this shortened the life of the filter.

- Suggest that established maintenance schedule be adhered to.
- Suggest that the date on the last cleaned acrylic sign be changed to due to be changed
