Machine Failure and Damage

SLQ Wiki Fabrication Lab 2026/04/13 01:00

This is a non-exhaustive list of our fails with the Trotec Rayjet 300. Please edit and expand as you see fit.

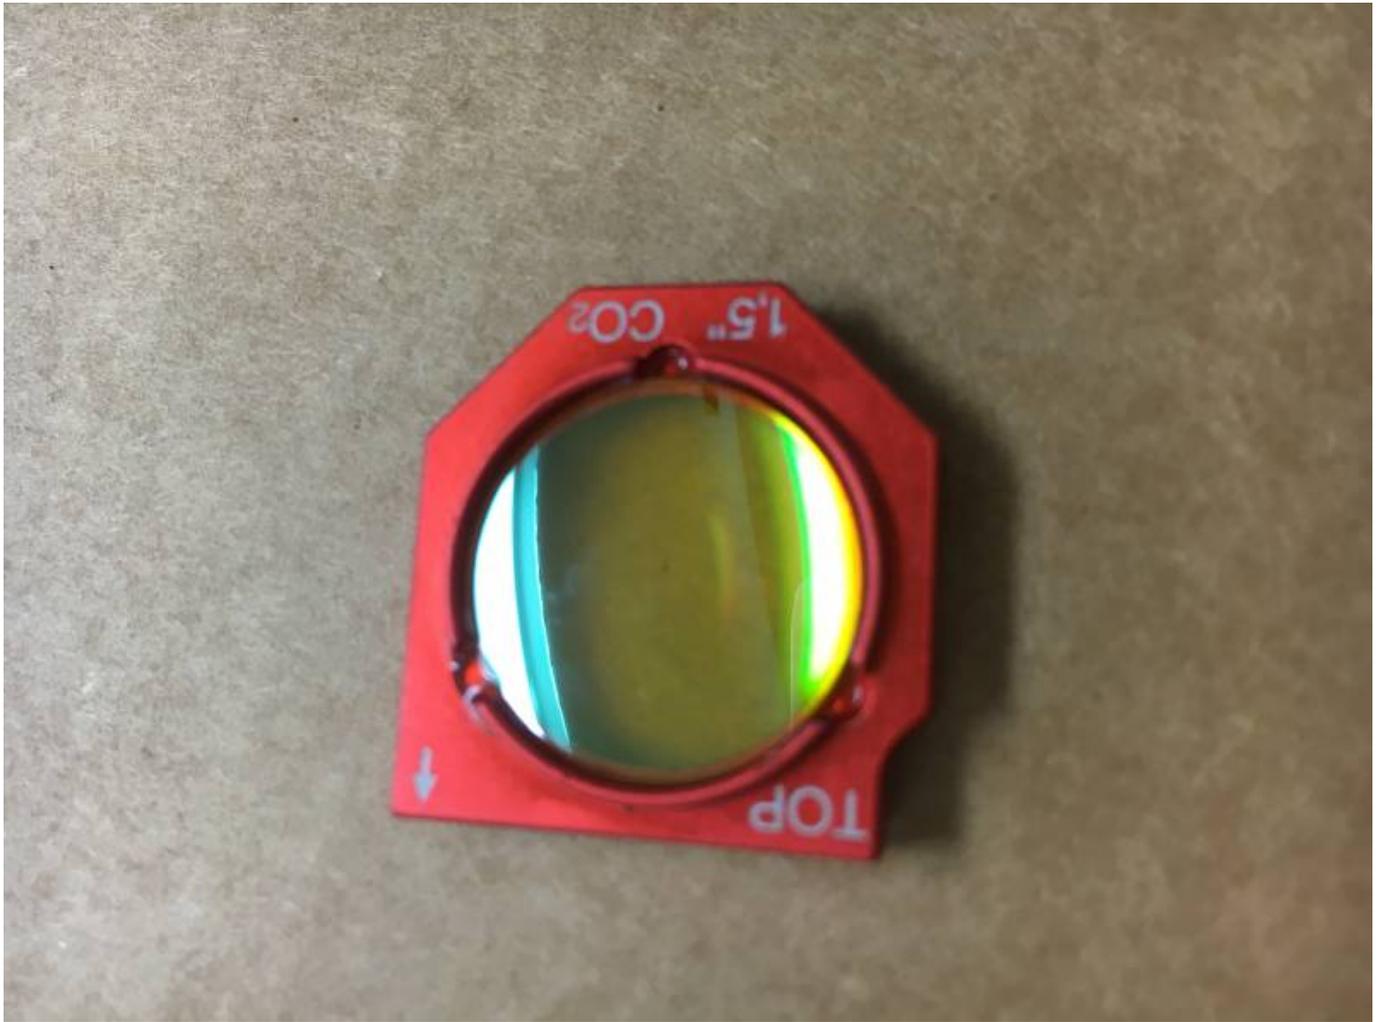
Thursday 25 Aug Brendan reported crack in the lens found after laser was cutting underpowered.

Photos show black dot inside body of lens. this will grow. Questions to be asked about

Michael from trotec came out with Temporary replacement (different size lens 2") that did not end up fitting. 2x stock lenses (1.5") are on order from Sydney. Michael cleaned damaged lens and said it would be right to use but that it was on its way out.

- is cleaning being done regularly enough.
- is cleaning being done to the Right standard
- lens being mis handled. finger oil damaging

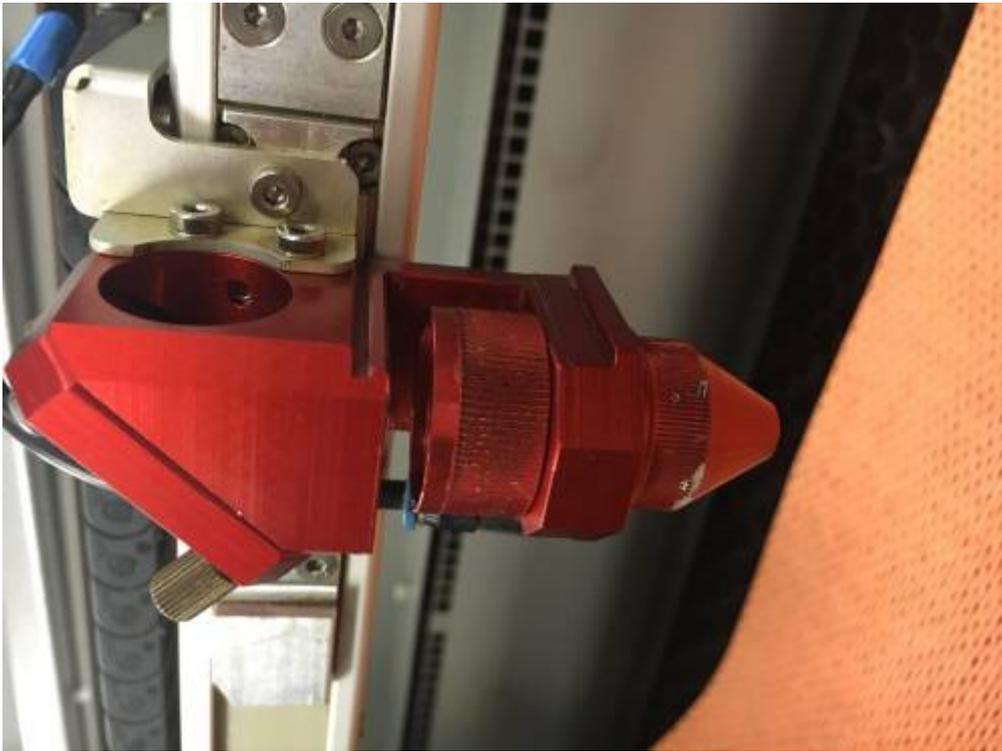
1. unscrew lens retaining collar
2. remove 1.5" lens (Red)
3. continue unscrewing lens retaining collar. Once completely unscrewed remove from lens/mirror assembly and rotate 180Deg
4. screw rotated collar into threaded receiver. This receiver is directly below face that the 1.5" Lens rests on.

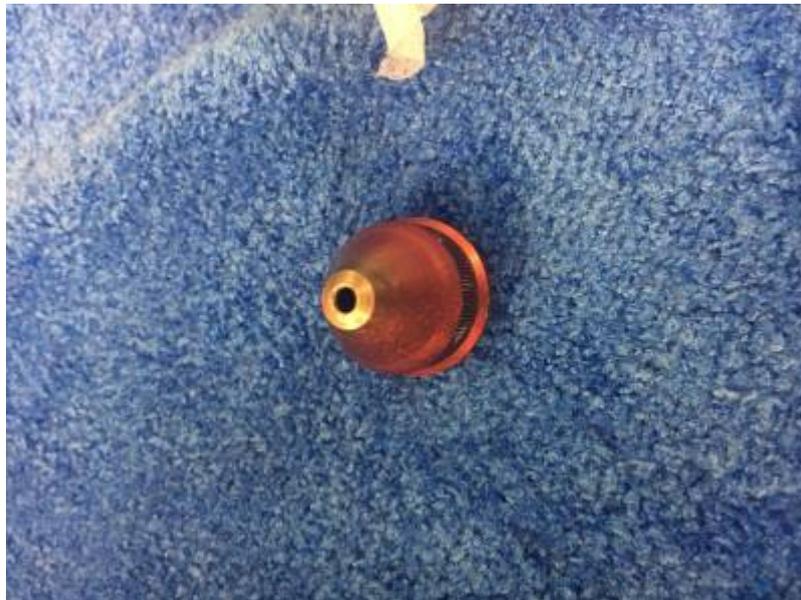
Heat Damage to Nozzle 06 Oct

Had an incident this evening where the 1st laser job at the HtE was well and truly under power. When i went to inspect the lense i found that all the parts of the Laser Head (Lense, mirror, retaining collar, and head body)was overheated (approx 60C). We left this to cool before cleaning anything.

The only explanation i can give is that perhaps the trusted participant that cleaned the Laser after their session accidentally or unknowingly reassembled the Lense/retaining collar upside down. (Lense on top of collar for 2"; lense Collar on top of Lense for 1.5" lense) This would have put the laser beam badly out of focus and directed energy at the nozzle which is now heat affected.

This is just a theory... i don't know for sure and wouldn't want to blame this participant. However if it is true the incident points possibly to a failure to communicate new procedures to the couple of trusted participants we allow to clean the machine and possibly to other level 3 facilitators we'd trust to operate and supervise the machine.

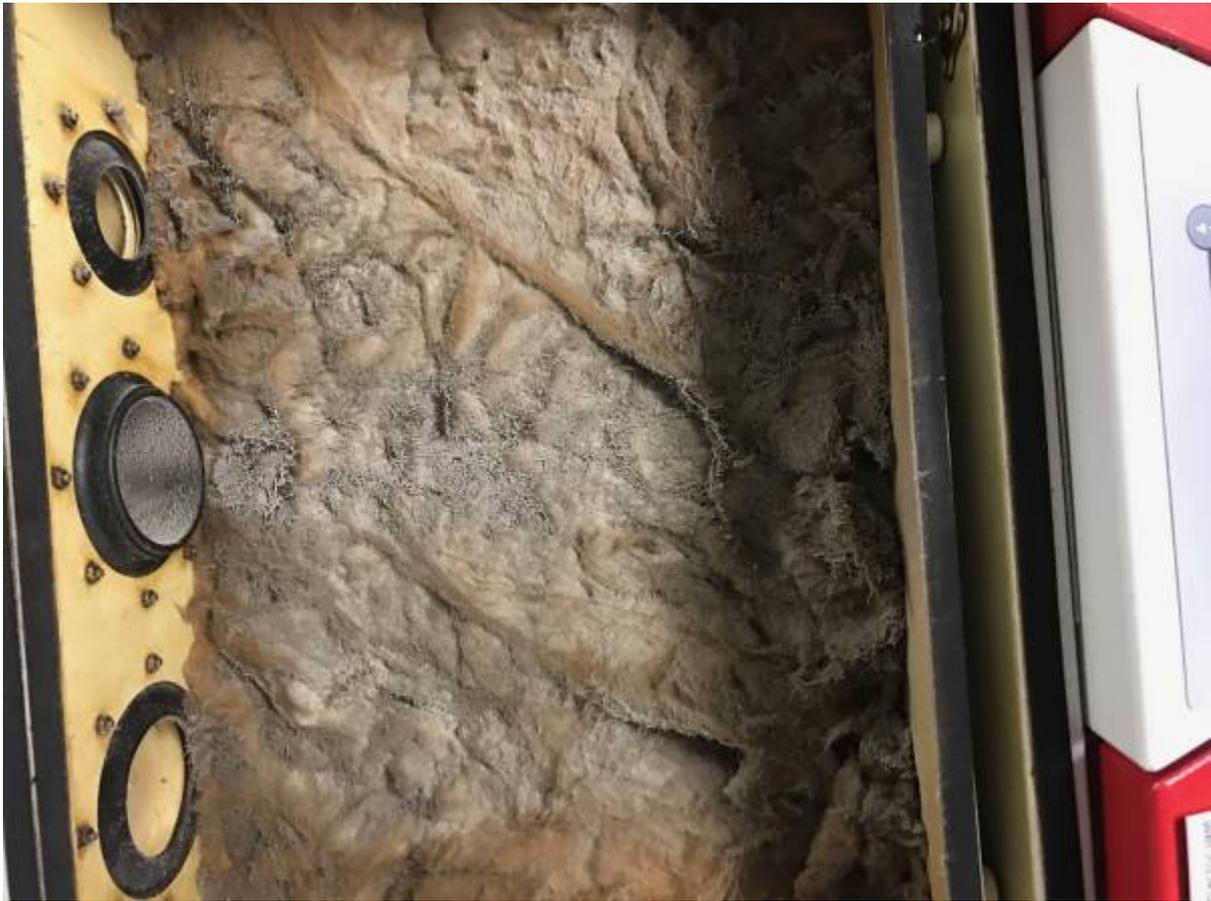
Filthy ATOMOS Filter

The filter had not been cleaned in over two months. The pre-filter was caked solid with materials and the HEPA component of the filter system blew out. Would suggest that this as a direct result of the lack of cleaning and maintenance on the system and that this shortened the life of the filter.

- Suggest that established maintenance schedule be adhered to.
- Suggest that the date on the *last cleaned* acrylic sign be changed to *due to be changed*
