Machine Failure and Damage

SLQ Wiki Fabrication Lab 2025/11/22 11:00

This is a non-exhaustive list of our fails with the Trotec Rayjet 300. Please edit and expand as you see fit.

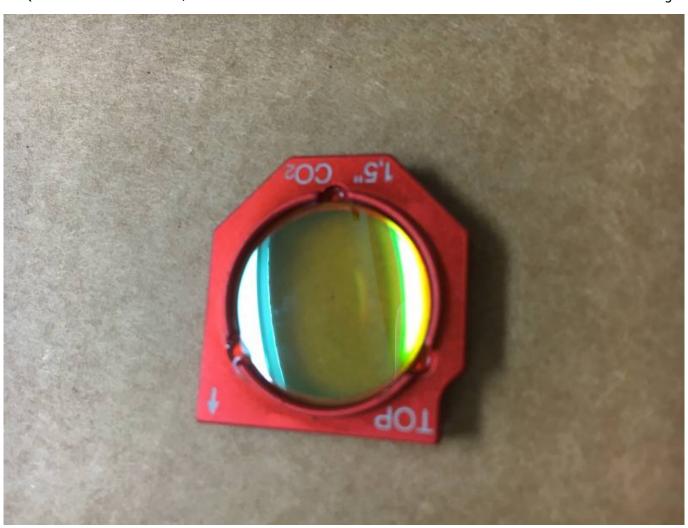
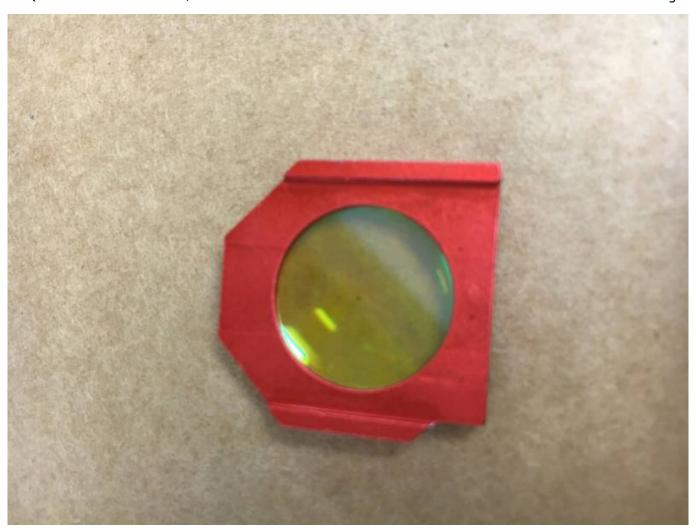
Thursday 25 Aug Brendan reported crack in the lens found after laser was cutting underpowered.

Photos show black dot inside body of lens. this will grow. Questions to be asked about

- is cleaning being done regularly enough.
- is cleaning being done to the Right standard
- lens being mis handled. finger oil damaging

Michael from trotec came out with Temporary replacement (different size lens 2") that did not end up fitting. 2x stock lenses (1.5") are on order from Sydney. Michael cleaned damaged lens and said it would be right to use but that it was on its way out.

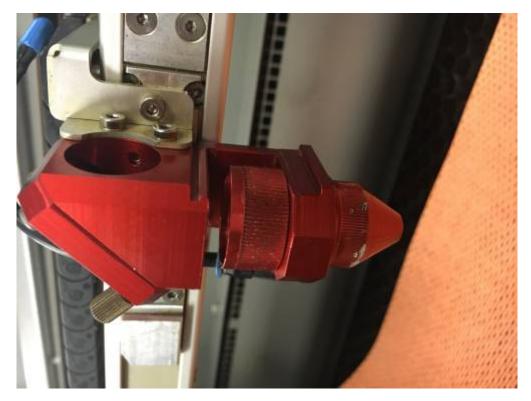
- 1. unscrew lense retaining collar
- 2. remove 1.5" lense (Red)
- 3. continue unscrewing lense retaining collar. Once completely unscrewed remove from lense/mirror assembly and rotate 180Deg
- 4. screw rotated collar into threaded receiver. This receiver is directly below face that the 1.5" Lense rests on.

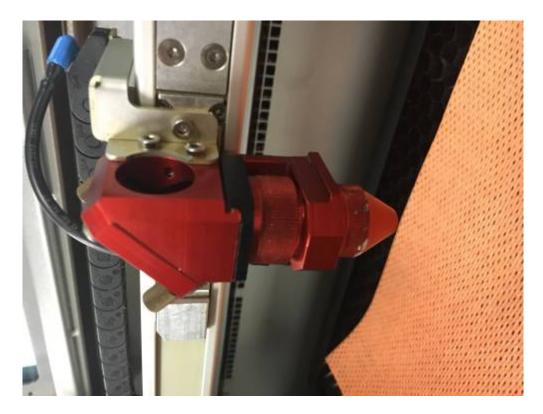
2" Lense (Black) 2" Lense Focal Length Calibration Tool

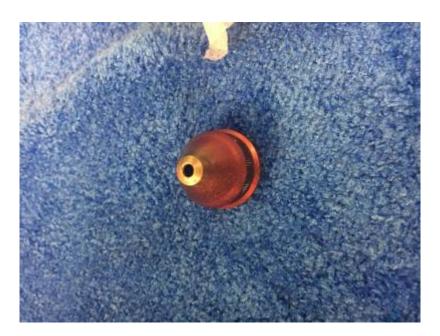
Heat Damage to Nozzle 06 Oct

Had an incident this evening where the 1st laser job at the HtE was well and truely under power. When i went to inspect the lense i found that all the parts of the Laser Head (Lense, mirror, retaining collar, and head body)was overheated (approx 60C). We left this to cool before cleaning anything.

The only explanation i can give is that perhaps the trusted participant that cleaned the Laser after their session accidently or unknowingly reassembled the Lense/retaining collar upside down. (Lense on top of collar for 2"; lense Collar on top of Lense for 1.5" lense) This would have put the laser beam badly out of focus and directed energy at the nozzle which is now heat affected.

This is just a theory... i don't know for sure and wouldn't want to blame this participant. However if it is true the incident points possibly to a failure to communicate new procedures to the couple of trusted participants we allow to clean the machine and possibly to other level 3 facilitators we'd trust to operate and supervise the machine.

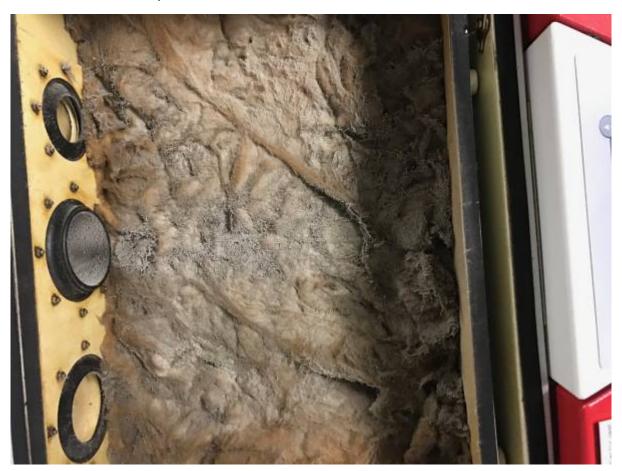
Filthy ATOMOS Filter

The filter had not been cleaned in over two months. The pre-filter was caked solid with materials and the HEPA component of the filter system blew out. Would suggest that this as a direct result of the lack of cleaning and maintenance on the system and that this shortened the life of the filter.

- Suggest that established maintenance schedule be adhered to.
- Suggest that the date on the last cleaned acrylic sign be changed to due to be changed
